Part # U7002 Instructions

Bolt-In Front Upper Extended Shock Mounts for 1967-1991 GMC/Chevy Full-Size

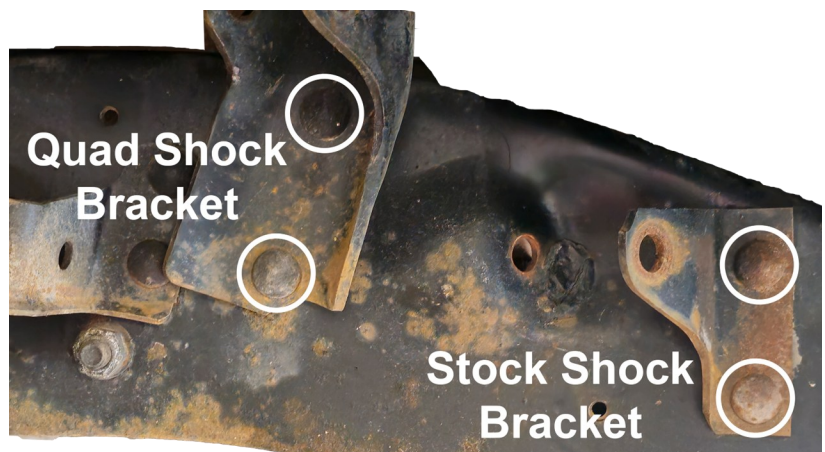
****You should verify shock clearance at droop and compression before driving vehicle. Since our mount relocates the shock to a more vertical position, some scenarios can result in lower axle side shock mount clearance issues.****
